6
National Dam Safety Program. New Dam
(NDI-PA-503), Ohio River Basin, Tributary
of St. Patricks Run, Washington County,
Pennsylvania. Phase I Inspection Report,

PHASE I REPORT
NATIONAL DAM INSPECTION PROGRAM

NAME OF DAM: New Dam
STATE LOCATED: Pennsylvania
COUNTY LOCATED: Washington
STREAM: A tributary of St. Patrick's Run (secondary tributary of
Raccoon Creek
DATE OF INSPECTION: November 29 and December 20, 1978

NEW DAM
NDI I.D. NO. PA-503
NOVEMBER 29, 1978

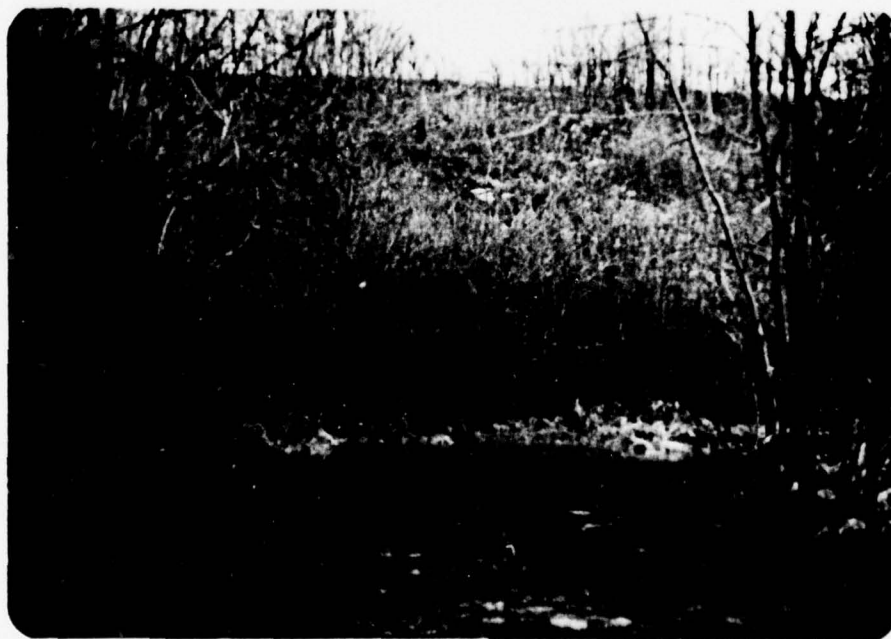
Downstream Face

In general, the condition of the embankment is considered to be poor. The embankment is covered with trees and brush 10 to 15 feet high and up to three inches in diameter. The overgrowth prevented adequate inspection of the downstream face of the dam. There is no direct line of sight from abutment to abutment. The presence of ponded water along the downstream toe of the dam suggests underseepage when reservoir levels are high. However, on the date of inspection, no signs of seepage were observed from the ponds.

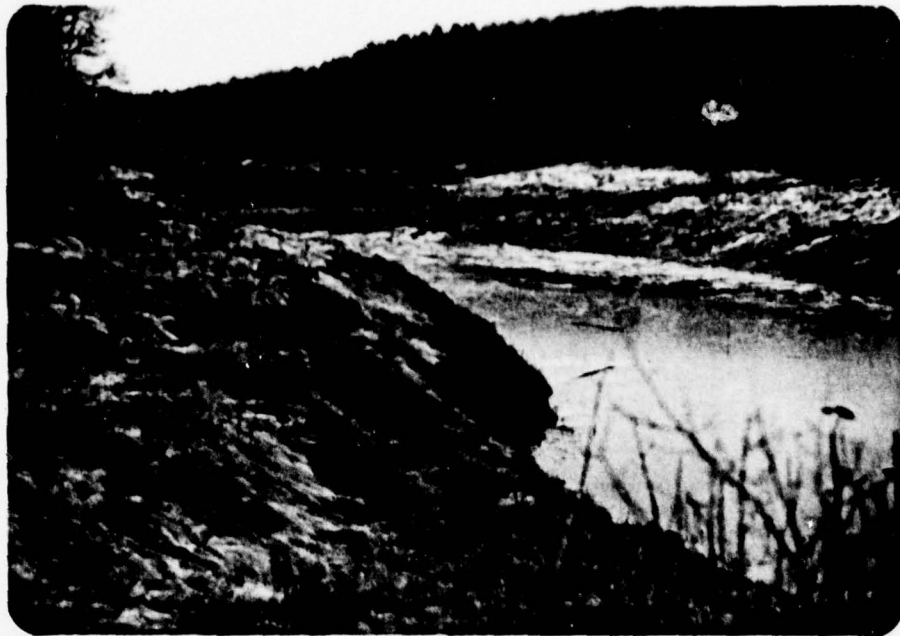
Photograph No. 1
Reservoir.

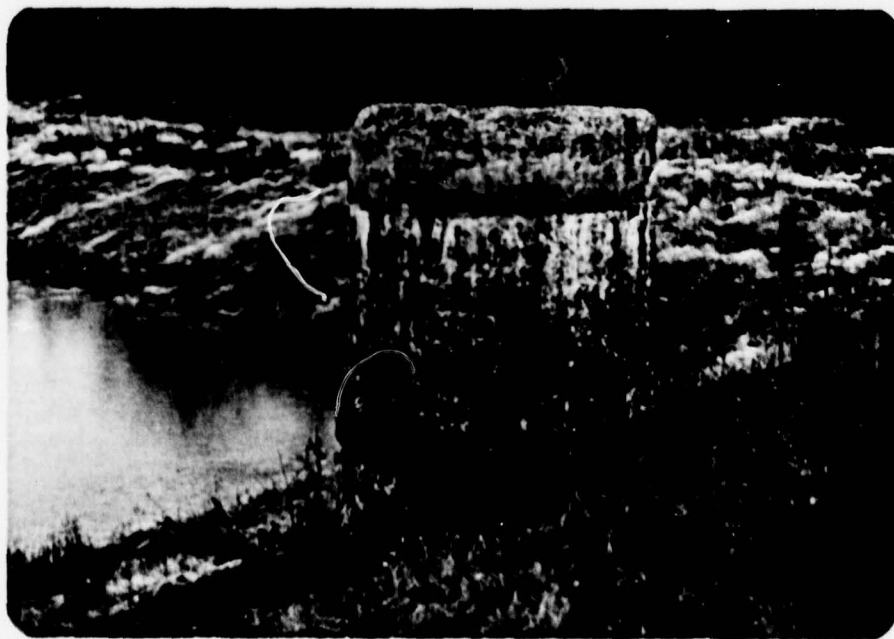
The outlet works have also seriously deteriorated. The concrete in the intake tower has spalled and is crumbling. All the operating equipment in the intake tower has seriously deteriorated and is no longer functional. The valve on the outlet pipe at the downstream side of the dam also appears to be in a deteriorated condition.

4.5 Evaluation. The dam has been abandoned and is no longer being maintained. The operating facilities, such as the sluice gates and the gate hoists in the intake tower, have deteriorated to such an extent that they are no longer operable. The general maintenance and operational condition of the dam is considered to be poor.

Photograph No. 4
Intake tower.

VISUAL EXAMINATION OF CRACKING AND SPALLING OF CONCRETE SURFACES IN OUTLET CONDUIT	OBSERVATIONS	REPAIRS OR RECOMMENDATIONS
	The outlet conduit is a 24-inch cast-iron pipe. No portion is visible.	
INTAKE STRUCTURE	Concrete intake tower is seriously deteriorated.	Repairs are required.
OUTLET STRUCTURE	Concrete valve chamber. Concrete is seriously deteriorated.	Repairs are required.
OUTLET CHANNEL	Earth channel.	
EMERGENCY GATE	Seriously corroded. Reported to be open.	Repairs are required.

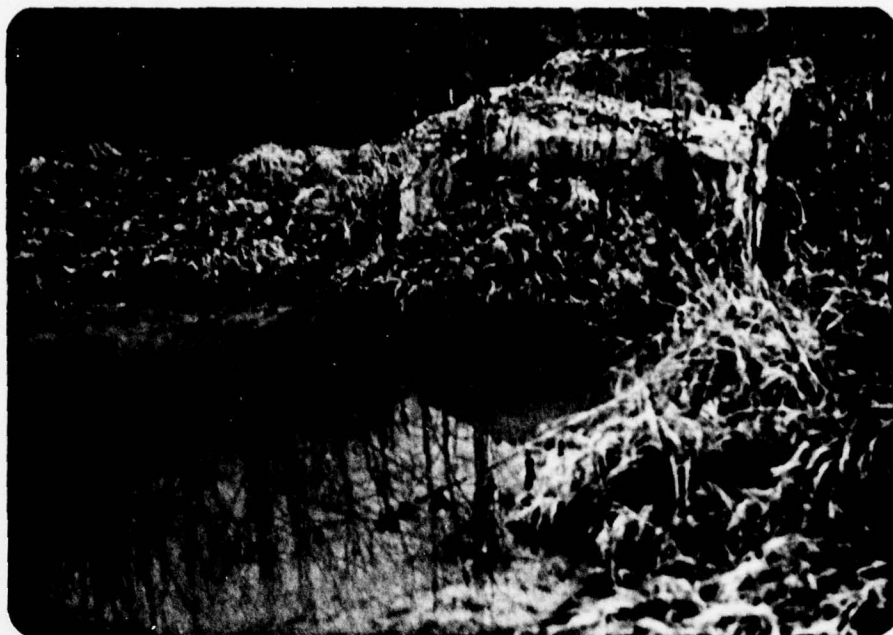
Photograph No. 5
Blow-off pipe (downstream end).

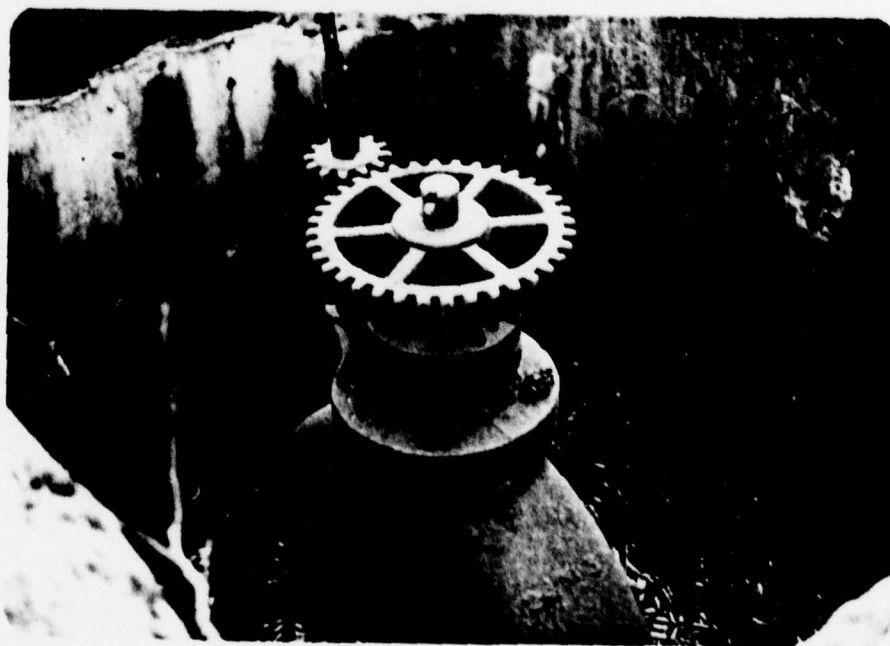
Photograph No. 6
Blow-off pipe valve at downstream end.
